“Niigataken Chuetsu-oki Earthquake and its Influences on the Kashiwazaki-Kariwa NPP”

Wataru Mizumachi and Masahide Kobayashi, JNES, Japan

A report on the summary of the incident at the Kashiwazaki-Kariwa Nuclear Power Plant caused by the Niigataken Chuetsu-oki Earthquake magnitude M6.8 that occurred on July 16.

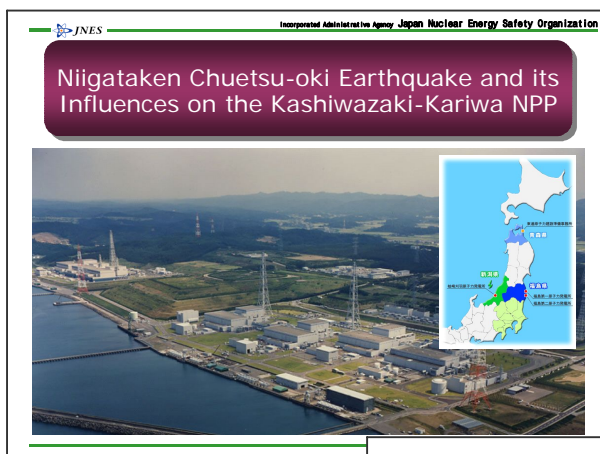
Main Incidents found in Inspections

Leakage of water including radioactive materials into non-controlled area in the reactor building (Unit 6)

Displacement of the main exhaust duct (Unit 3)

Damage found on the coupling of the drive axis of the reactor building overhead crane (Unit 6)

Fire on the house transformer B (Unit 3)
