Characteristic Radiological Protection Activities at Ikata NPP during outages

Shikoku Electric Power CO.,INC.

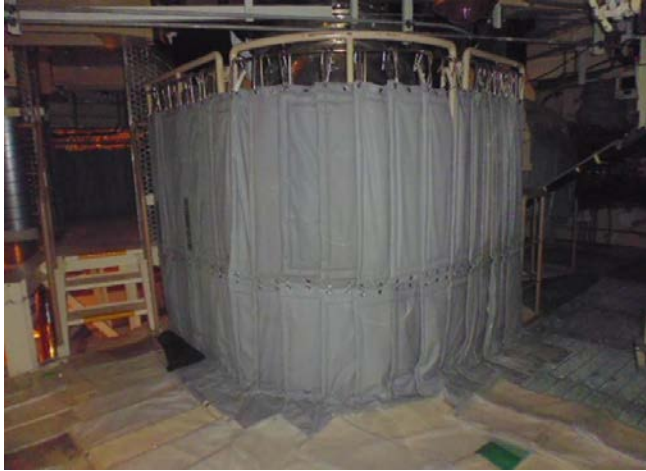
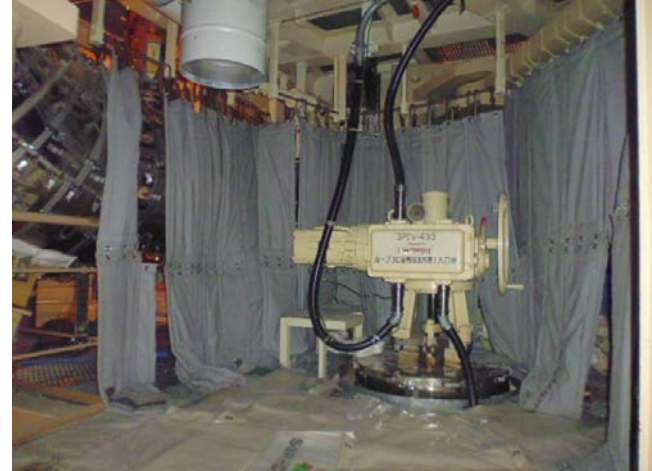
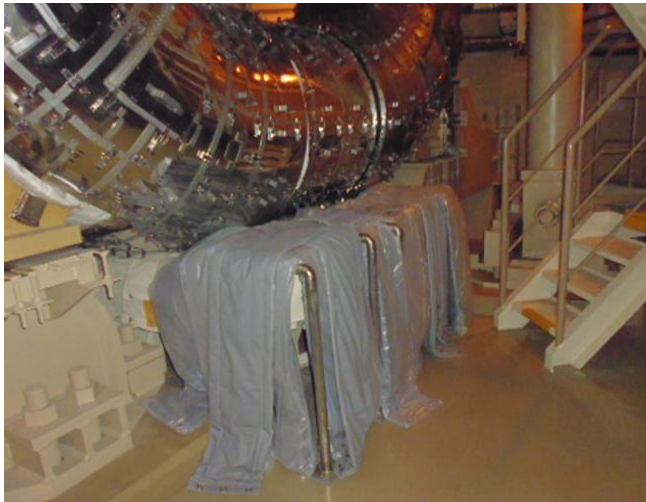
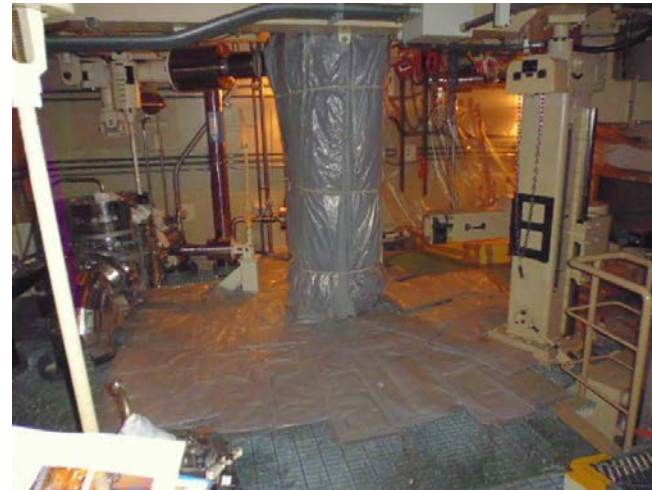
(Primary loop rooms)

Thousands of lead blankets are shared and installed according to outage activities.

(Details) Temporary shielding installation

Places	Number (as a 1m lead blanket)	Remarks
Primary loop rooms	1, 100	Installed by Station
Pressurizer room	100	Installed by Station
Other areas	100	Installed by Station
Rental to contactors for free	2, 000	Installed by contractors
Owned by contractors	1, 200	For special renovation works such as vessel head replacement
Total	4, 500

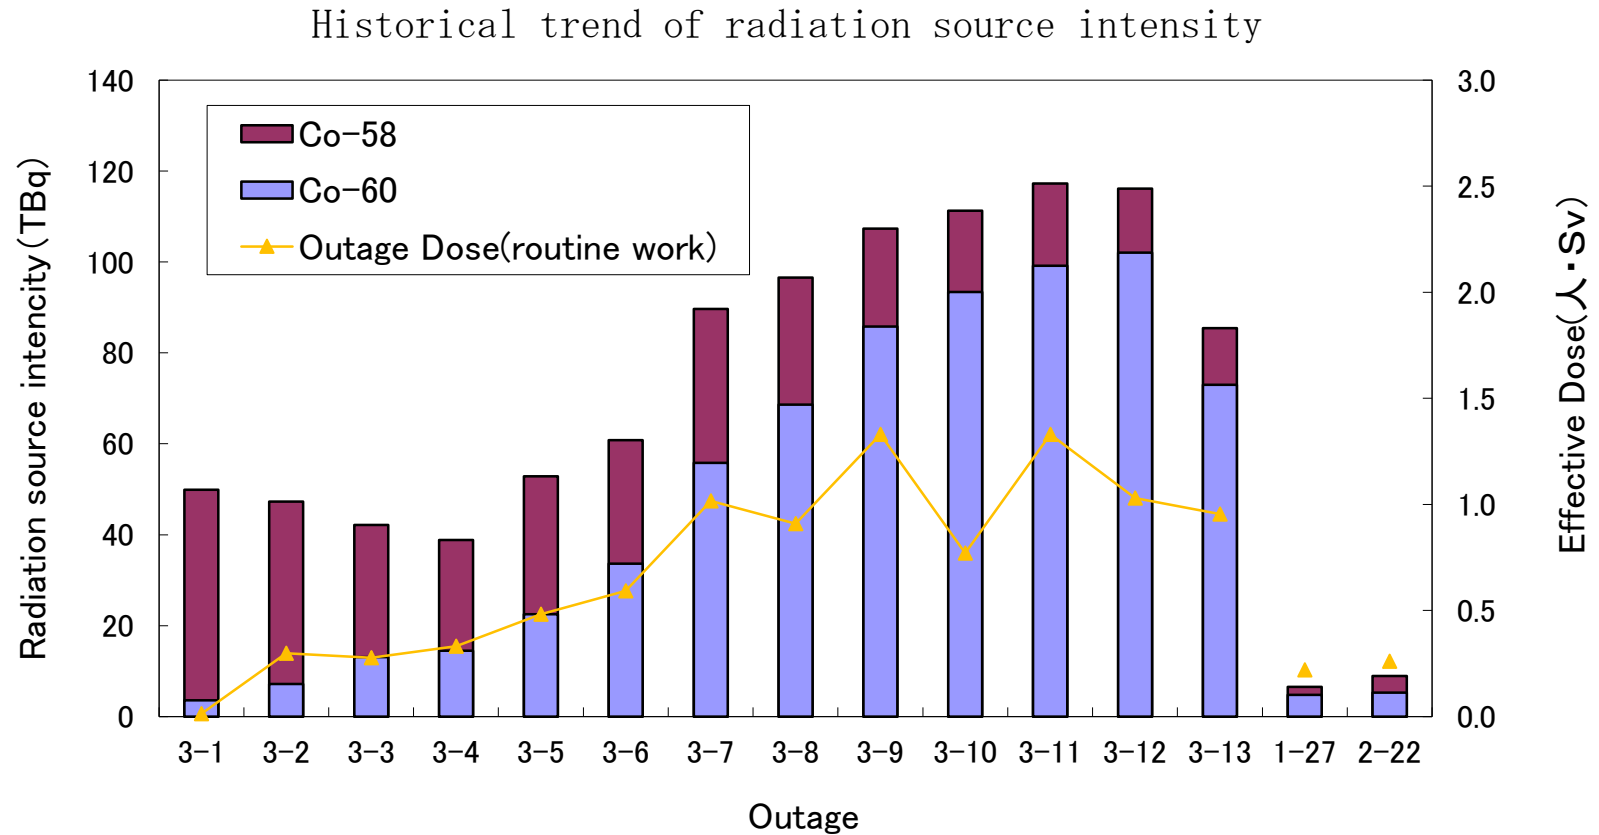
Radiation source intensities (especially Co-60) of unit 3 had rapidly built up from No.6 outage.

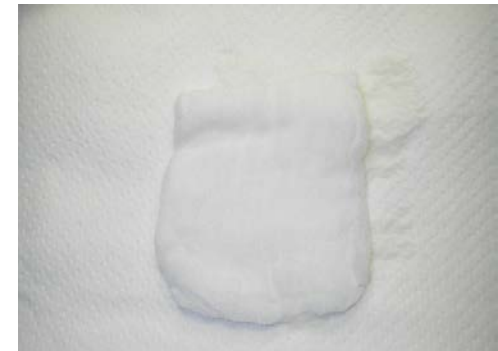
(Cleaning gauze)

Hexa plug installation and cleaning reference usages during valve maintenance have been conducted as countermeasures of source increase since No. 9 outage.

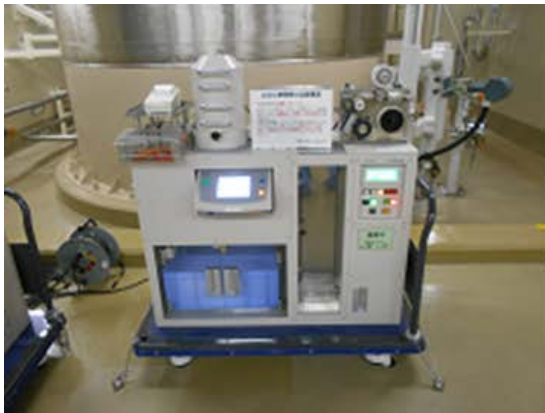
6 Smear devices
(for unit-3)

Smear sample auto measuring devices, cloths monitors, and Personal Protective Equipment (PPE) monitors are installed to detect radioactive contamination in an early stage.

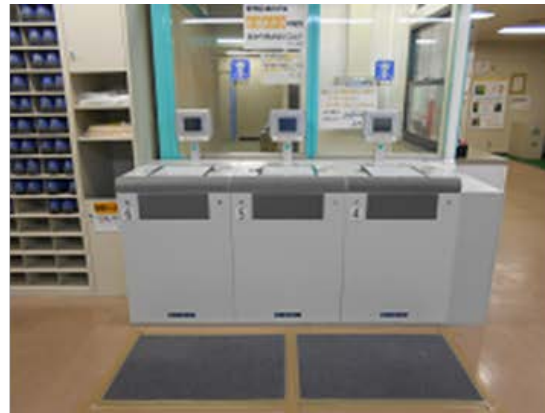
6 cloths monitors
before unit-3 portal
monitors

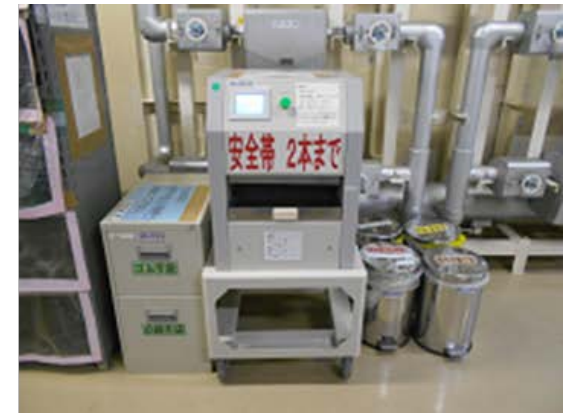
7 PPE monitors in
unit-3 RCA
